Original Research Article

Pavement Evaluation of Kampi Ya Moto - Eldama Ravine - Kamwosor B77 Road

Abstract: Assessment of pavement performance is essential in determining the serviceability and structural state of the pavement structure. Pavement failure and deterioration always commence immediately after the road has been opened to traffic. Several factors contributing to pavement failure and damage include traffic load, soil, environmental, economic, and stress distribution factor. Therefore, flexible pavement failure and deterioration are well-defined by alligator cracks, concentrated potholes, ruts, settlement, and localised depression. Pavement evaluation determines highway sections' functional and structural conditions for frequent monitoring or planning for maintenance. Kampi ya Moto-Eldama Ravine-Kamwosor (B77) road is a Kenya National Highways, Authority (KeNHA) class B road constructed in 2008. The length of the road is approximately 79.5 Km. However, the pavement had numerous distress features which developed even before the design life of the pavement was attained. The study, therefore, concentrated on evaluating the performance of the pavement to identify the type a

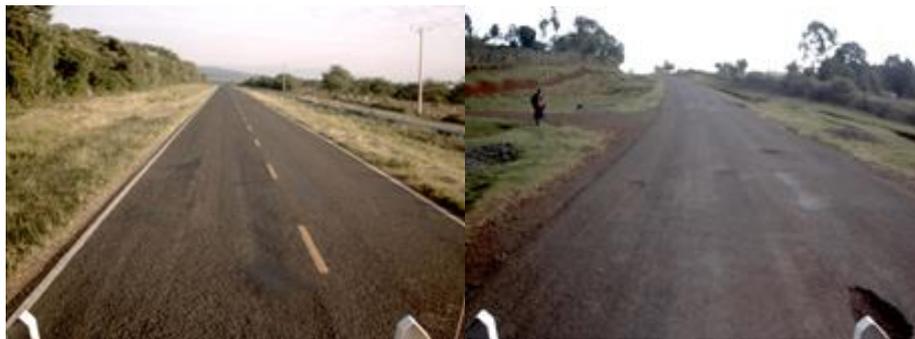
The minor distress observed that did not reflect on the structural state of the road included bleeding of the AC surface, as depicted in Figure 1. The primary structural distresses observed on the road have numerous potholes, eroded edges, block cracking, depression, deformation, rutting, and poor drainage, as depicted in Figure 2.

Figure 1: Minor distress and lack of drainage system on Kampi ya Moto-Kamwosor Road

- a. Maintain all the existing drainage, and in a case where the drains are not defined, drainage should be designed to enable the free flow of water.
- b. Carry out repairs on potholes, shoulders, and failed sections as a short-term intervention
- c. Lay 50 mm (0/20) asphalt concrete Type I binder course as a long-term intervention.
- d. Apply single seal surface dressing 10/14 mm pre-coated chippings as routine maintenance.
- e. Widening and reinstatement of shoulders, especially where the road is narrow and with no shoulders, respectively.

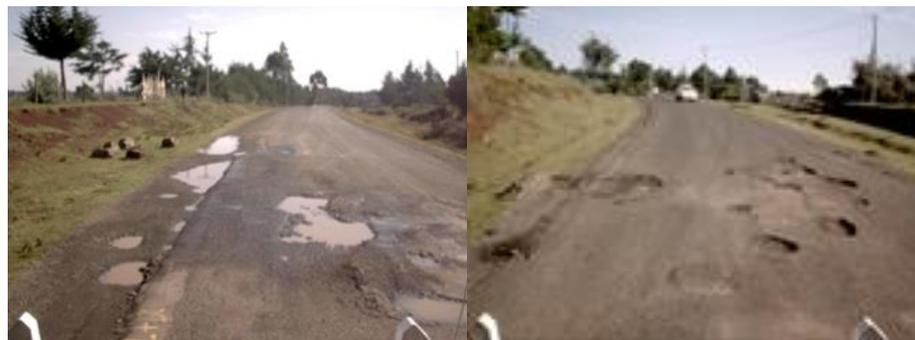
Figure 2: Major distress and lack of defined system

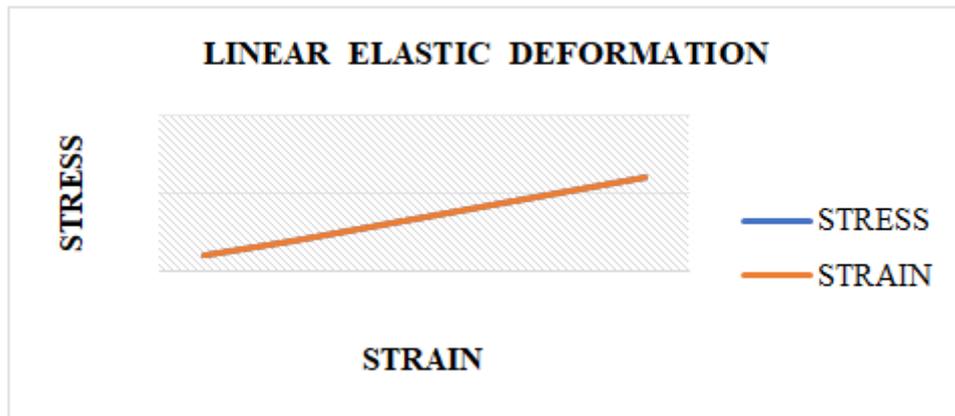
Road structure layers involve Surfacing, Base, Subbase, and Subgrade. In pavement, we are usually interested in the vertical change in position at the surface (e.g., due to a vehicle passing). In this view, Road pavement deformation results from the sum of all the vertical strains at every point beneath the surface. Deformation in an ideally elastic material is recoverable. The passage of a too-heavy wheel will tend to deform the pavement and thus return to its normal condition when the pressure is released. The continuous stress on the pavement will grow to change the vertical appearance of the road; therefore, permanent deformation of the pavement automatically outgrows. Strain is defined at a particular point, whereas deformation is defined as the change itself. Thus, in the flexible pavement, the stress and the strain will

gradually move parallel since deformation will occur once the two are defined. This is illustrated in fig 3 as

Figure 3: Illustrate that linear elastic deformation grows gradually in strain and stress

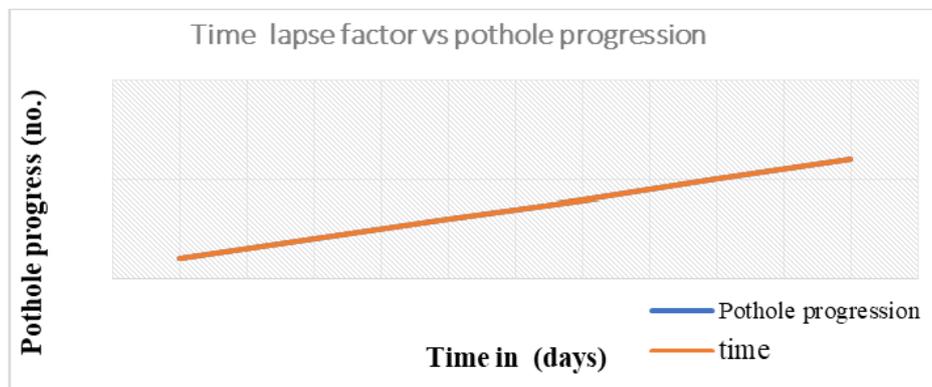
Pothole progression on the carriageway is usually a result of cracks needing to be attended to on time. Therefore, potholes will tend to progress gradually in time unless repaired. This can be illustrated in Fig 4, as shown below.

Figure 4: Pothole progression with time

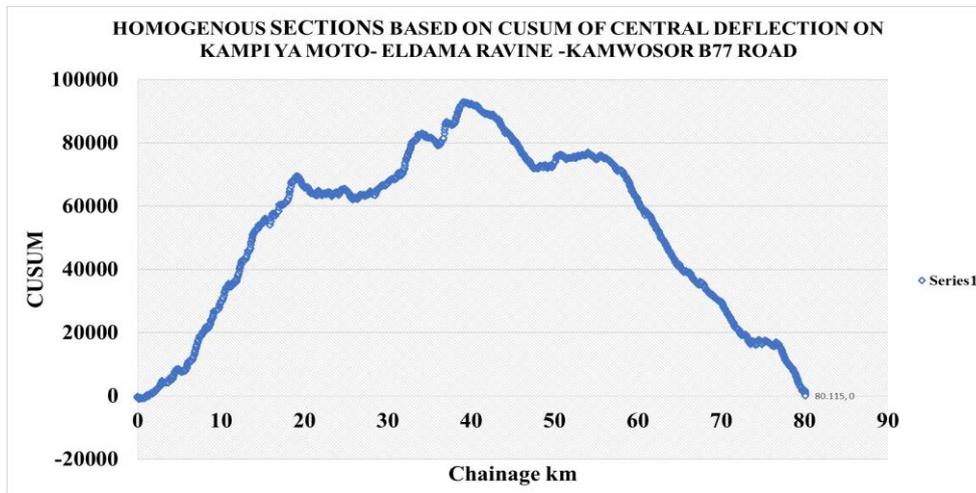
The computed CUSUM value is graphically presented in Figure 4-5. It indicates that the existing bitumen pavements on the project road have the following homogeneous sections: -

- Km 0+000 - Km 18+000
- Km 18+000 - Km 30+000
- Km 30+000 - Km 40+000
- Km 40+000 - Km 80+100

Figure 0-5: Cumulative Mean Difference from Mean (CUSUM) Values of Deflections on Bitumen Pavement of the Kampi ya mot- Eldama Ravine- Kamwosor (B77) Section
